Manhole Inspection Summary

Manhole # S41E__068MH

Insp Date: **9/12/08 9:56 AM**

Location Address: **side 1418 s caroline st**

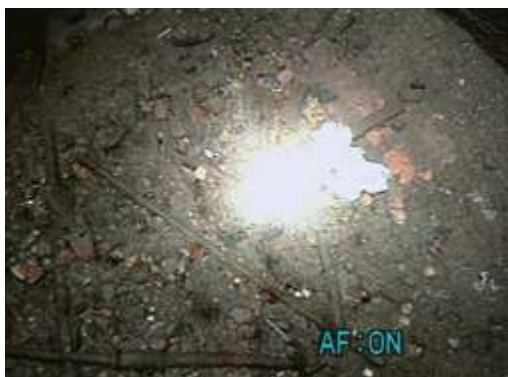
Defect 3

Condition: ☐ Sound ☐ Cracked ☐ Root Intrusion ☐ Deteriorated ☐ Leaks ☒ **Debris**

channel debris

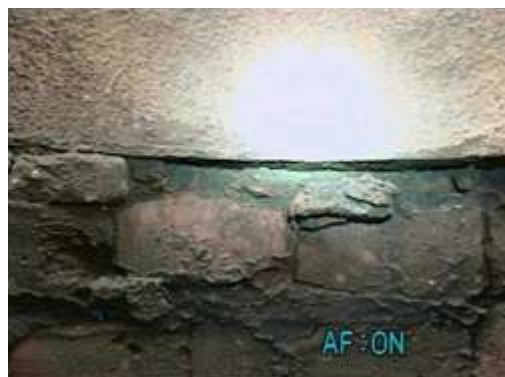
Defect 2

Condition: ☐ Sound ☒ **Cracked** ☐ Root Intrusion ☒ **Loose Brick** ☒ **Deteriorated**

chimney loose bricks,
cracked,deteriorated,
frame adj

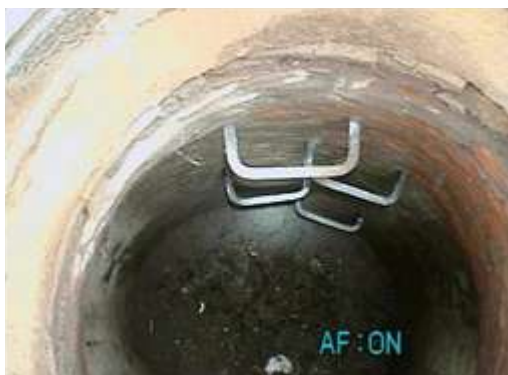
Defect 1

Infiltration: ☐ None ☒ **Joint** ☐ Cracks ☐ Mortar ☐ Roots ☐ Wall

Condition: ☐ Sound ☒ **Cracked** ☐ Root Intrusion ☐ Loose Brick ☐ Deteriorated

Count: **4** Missing: **0** ☒ **Corroded**

☒ **Evidence Of Surcharge** Depth: **5** (ft.) ☐ Active Surcharge Present

corroded steps, surcharge evidence,
barrel cracked (on left side of pic),
infiltration from chimney joint

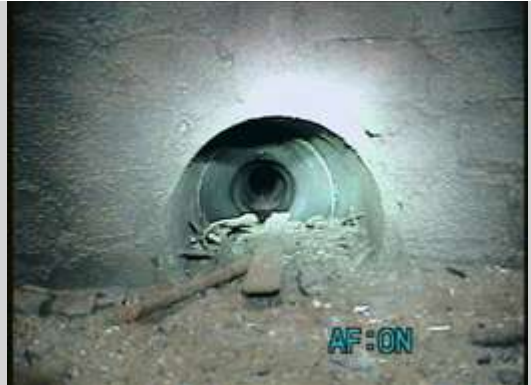
12 O'Clock Outflow

Deposits: ☐ None ☐ Mud ☐ Sludge ☒ **Debris** ☐ Grease

Silt Depth: **2.5** (in.) Deposits Extent: **Light**
